DEPARTMENT OF TRANSPORTATION**DIVISION OF ENGINEERING SERVICES**

Contract #: 04-0120F4Cty: SF/ALA Rte: 80 PM: 13.2/13.9File #: 69.28**WELDING INSPECTION REPORT****Resident Engineer:**Pursell, Gary**Address:** 333 Burma Road**City:** Oakland, CA 94607**Report No:** WIR-001753**Date Inspected:** 09-Mar-2008**Project Name:** SAS Superstructure**OSM Arrival Time:** 1830**Prime Contractor:** American Bridge/Fluor Enterprises, a JV**OSM Departure Time:** 730**Contractor:** Zhenhua Port Machinery Company, Ltd (ZPMC), Changxing Island **Location:** Shanghai China

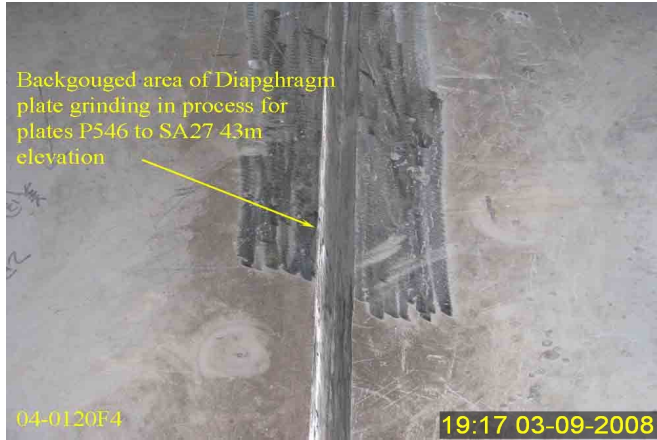
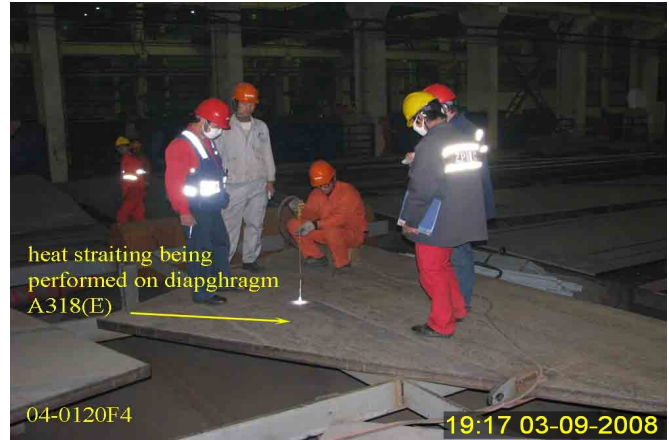
During the continued observations at ZPMC this QA inspector noted that ZPMC personnel were performing heat straitening for diaphragm A318 (E) using a rose bud and predetermined locations along the part. The procedure being applied was HSR 1 (T) 084 which has a maximum temperature of 600° c. This QA inspector observed ZPMC QC personnel Yang Qin Feng, Zhao Chen Sun and Chen Chen monitoring and documenting parameters obtained for the heat striating process. Also noted was diaphragm plates P546 and SA 27 that had been welded together had been back gouged and was in the process of grinding the joint to a bright finish to continue with the welding process. This diaphragm is for elevation of 43m. The above work appeared to be within the general requirements of the contract documents. See digital photos below for grinding of the back gouged joint and heat striating process.
